## **Improper Seam Sealing on Canning Equipment**

- Determine the cause of improper seam sealing on the can filler/seamer equipment.

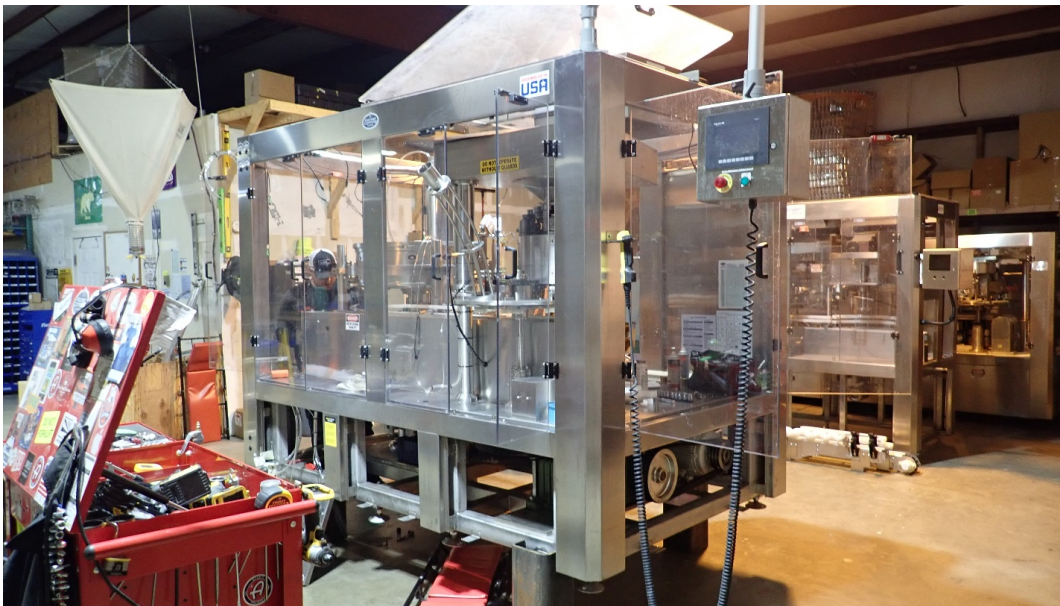
- Two years after the can filler/seamer was purchased new, it was discovered that random cases of cans were experiencing seam failures during production as well as leaking from punctures.
- All of the cam followers for the seaming head had seized due to over-usage.
- All bearing rollers were missing on the bottom bearing of one of the can conveyor rotating shafts.
- Fill system actuation forks exhibited wear beyond their useful life.
- Inadequate lubrication was found on several components.
- For proper can seal, it was required that each of the four stations was properly shimmed prior to operation (based on the height/geometry of the given can) and all rollers/cam followers must be operational (not seized).

- ILC concluded that improper sealing of the cans was due to individual components not performing as intended due to the lack of proper and timely maintenance of the machine.
- The seized cam rollers were caused flat spots on the cans, not allowing them to seal properly.
- Reported can punctures were consistent with improperly adjusted (inadequate shims) or broken machine components contacting cans during or after the seaming operations on the machine.
