Forging Press

ILC Assignment:

- Retained by the manufacturer to determine the cause of surface anomalies on the pistons of a new installation, along with confirm extent of damage and reparability of the cylinders.
- One of the world's three largest forging presses used to manufacture crankshafts up to 47' long for the world's largest engines
- If repairable, determine recommendations for repair of the hydraulic cylinders on the forging press.

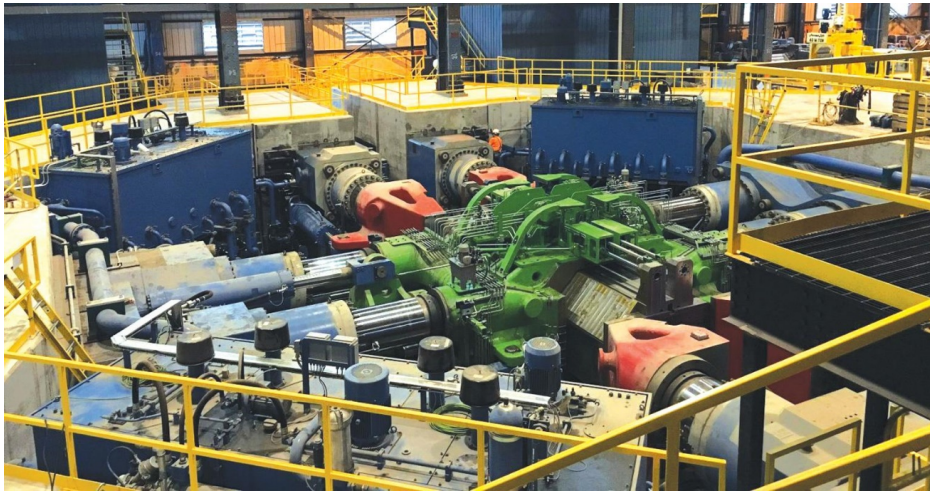
- The surface anomalies had not caused any observable, large-scale hydraulic leaks at the time of our inspection, but were cause of concern.
- ILC identified roof leaks that allowed stormwater to enter the building and contact forging press cylinders.
- The forging press is located in a non-climate controlled industrial building.
- Weather history available from the National Weather Service indicated that since installation, the period of time before the corrosion appeared had the lowest recorded temperatures in the year, and largest changes in low to high temperatures for a given day.

- Based on the investigation, the surface anomalies were caused by moisture, two sources, roof leaks, and condensation.
- Press manufacturing error eliminated as a cause, absolving client and their insurer of liability.
- Recommended mapping and monitoring the cylinder condition for changes in manifestation and severity prior to proceeding with any cylinder repairs since the current anomalies were not affecting the hydraulic seals to the point of allowing large-scale hydraulic system leaks.
