Grinding / Chopping Equipment

ILC Assignment:

- Determine the cause of damage, the extent of damage, and confirm the repair costs associated with the repair of the 2016 Rotochopper MC266 horizontal grinder.

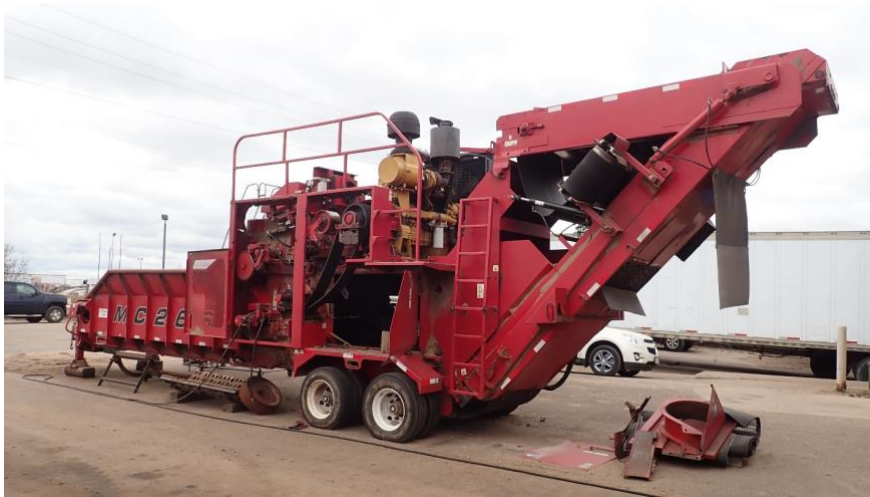
- Grinder was being utilized to pulverize wood.
- A few months after the grinder was purchased new, it suffered several mechanical failures and required substantial service part replacement.
- Since the part replacement, persistent breakdowns have occurred.
- Nearly \$100,000 has been spent for service parts and repairs to keep the grinder operating.
- Three years after the grinder was purchased new, the insured determined that the chopper had suffered a nearly catastrophic failure and could no longer operate.

- The long list of failures to the grinder was attributed to continuous operation with a severe vibration due to an improperly repaired main rotor, which was operating out of dynamic balance since the first rotor tooth mount failure.
- ILC concluded that the recent failure of the grinder was the result of improper repairs, a lack of proper and timely maintenance, and user misuse.
- ILC concluded replacement of the machine was not necessary to restore proper operation.
- The required repairs, totaling \$125,967, were the culmination of continued operation of a machine, repaired without adherence to industry-accepted practices or original equipment manufacturer support.
