Improper Seam Sealing on Canning Equipment

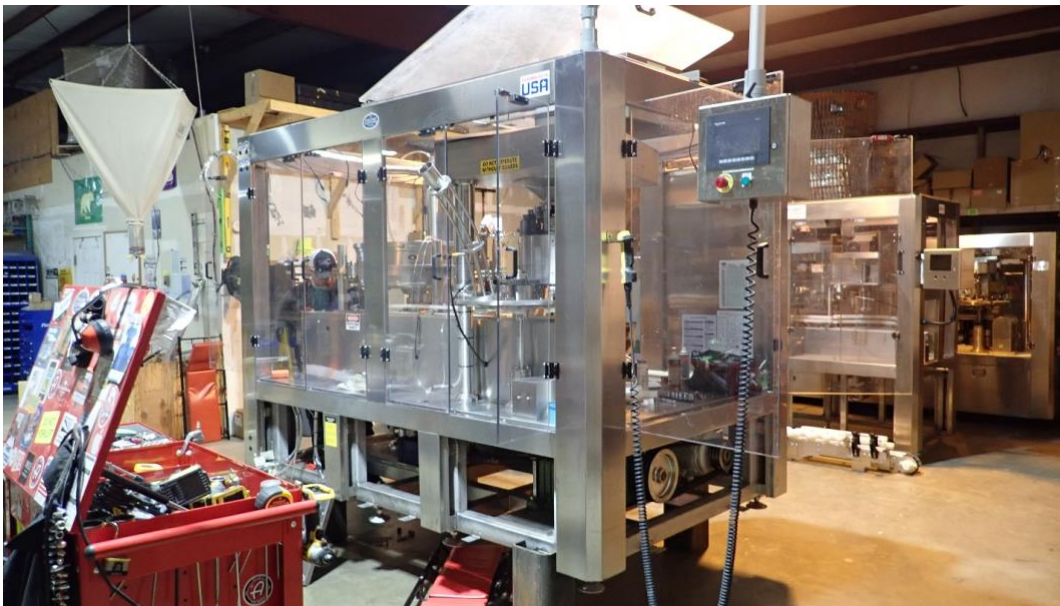
- Two years after the can filler/seamer was purchased new, it was discovered that random cases of cans were experiencing seam failures during production as well as leaking from punctures.
- All of the cam followers for the seaming head had seized due to over-usage.
- All bearing rollers were missing on the bottom bearing of one of the can conveyor rotating shafts.
- Fill system actuation forks exhibited wear beyond their useful life.
- Inadequate lubrication was found on several components.
- For proper can seal, it was required that each of the four stations was properly shimmed before operation (based on the height/geometry of the given can) and all rollers/cam followers must be operational (not seized).

- ILC concluded that improper sealing of the cans was due to individual components not performing as intended due to the lack of proper and timely maintenance of the machine.
- The seized cam rollers were caused by flat spots on the cans, not allowing them to seal properly.
- Reported can puncture was consistent with improperly adjusted (inadequate shims) or broken machine components contacting cans during or after the seaming operations on the machine.
