Lightning Damaged Electrical Equipment

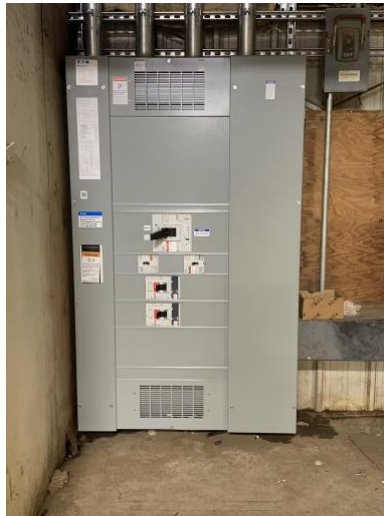
- ILC acquired documentation and reviewed the repair parts, services, and costs that were completed. Almost \$8,132.00 in labor cost invoices were received with an overall downtime of 3 weeks.
- ILC identified that submitted photographs illustrated copper busbar, conductors, and contractors, which appeared to be overloaded and burned. The photographs also appeared to indicate damage to conducting elements on the roof.

- ILC confirmed that the electrical repairs were of LKQ parts, and the prices charged were in line with the industry.
- ILC determined that given the scope of and nature of the repair work, the time spent removing the damaged remnants, installing the replacement components, and returning electrical service to the facility was reasonable.
- ILC confirmed the electrical equipment could be returned to pre-loss condition by replacing the electrical switchgear for \$48,250.
