## Indoor Water Park Flood Loss

### ILC Assignment:

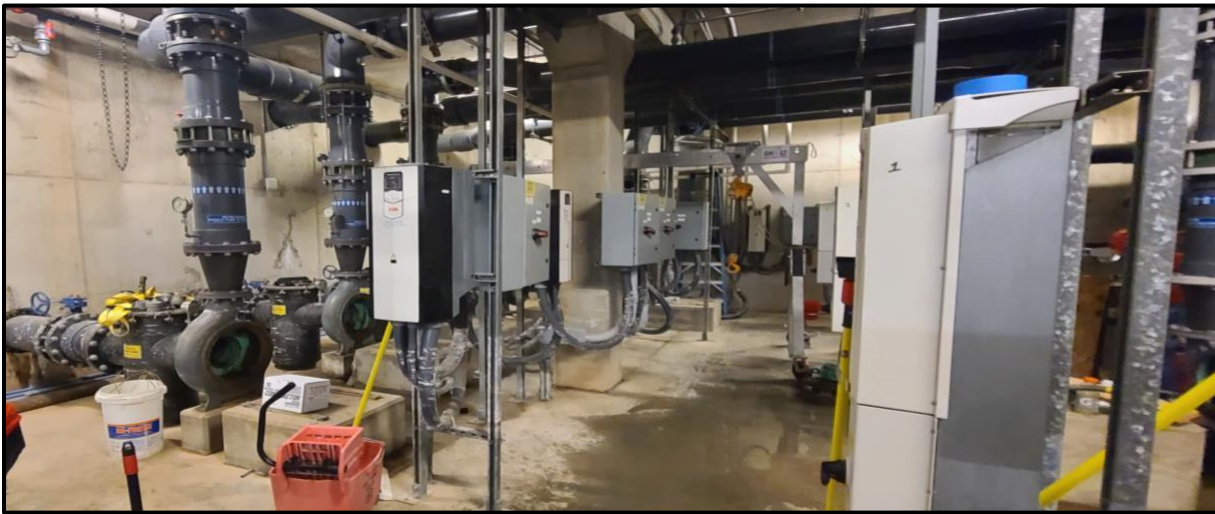
- Since ILC was at the site soon after the flood, ILC was able to identify what electrical distribution equipment was damaged from the flood loss event and which was not.
- ILC identified and documented electrical distribution equipment that exhibited corrosion above the high water line which existed prior to the flood event due to the working environment (chlorine vapors in the mechanical and electrical rooms).
