## **Flood Damaged Restaurant**

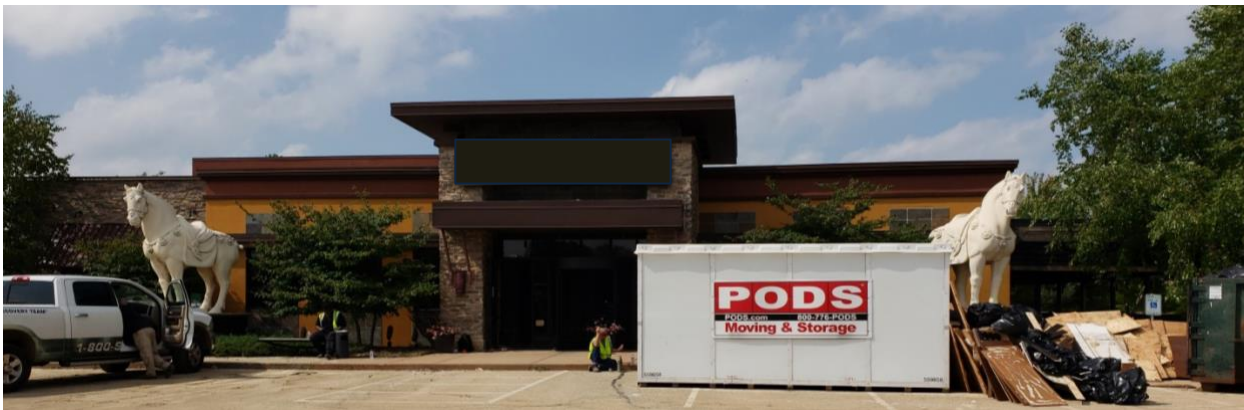
- During the visual inspection, ILC documented high watermarks up to 14”.
- The walk-in coolers showed mud residue left behind from flood waters receding.
- The main chef/prep line was deemed uneconomical for restoration or repair and required replacement based on the inspection.
- Portable coolers in the front bar were deemed destroyed due to their electrical systems being submerged.
- A beverage island, drink station, kitchen ranges, fryers and woks, dishwashing system, and numerous kitchen utensils and dishes were all candidates for cleaning and sanitizing.

- ILC priced all destroyed items reviewed from inspection and estimated the ACV as \$63,334.57.
- ILC validated a complete replacement cost for all items deemed destroyed totaling \$208,250.09.
