Flood Damaged Restaurant

ILC Assignment:

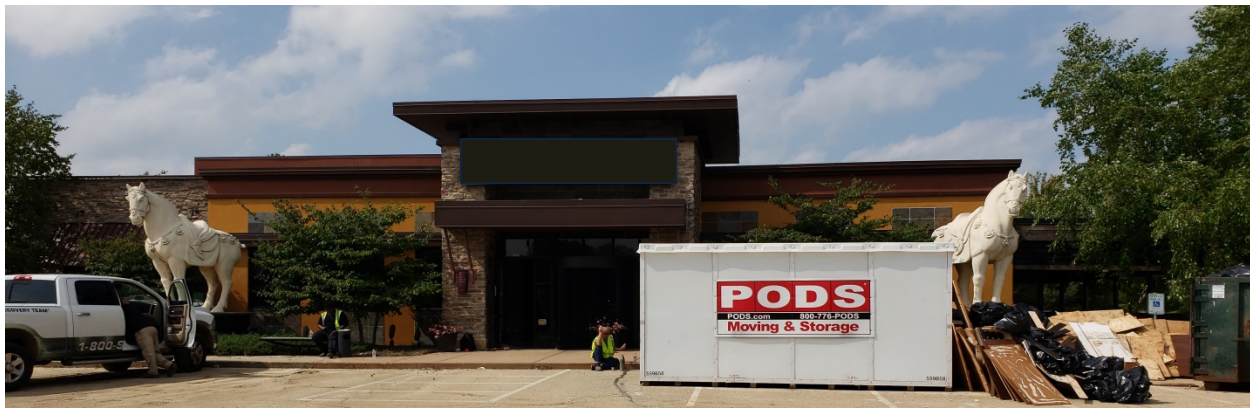
- During the visual inspection, ILC documented high water marks up to 14”.
- The walk-in coolers showed mud residue left behind from flood waters receding.
- The main chef/prep line was deemed uneconomical for restoration or repair and required replacement based on the inspection.
- Portable coolers in the front bar were deemed destroyed due to their electrical systems being submerged.
- A beverage island, drink station, kitchen ranges, fryers and woks, dishwashing system and numerous kitchen utensils and dishes were all candidates for cleaning and sanitizing.
