## Grinding / Chopping Equipment

### ILC Assignment:

- Determine the cause of damage, extent of damage, and confirm the repair costs associated with repair of the 2016 Rotochopper MC266 horizontal grinder.

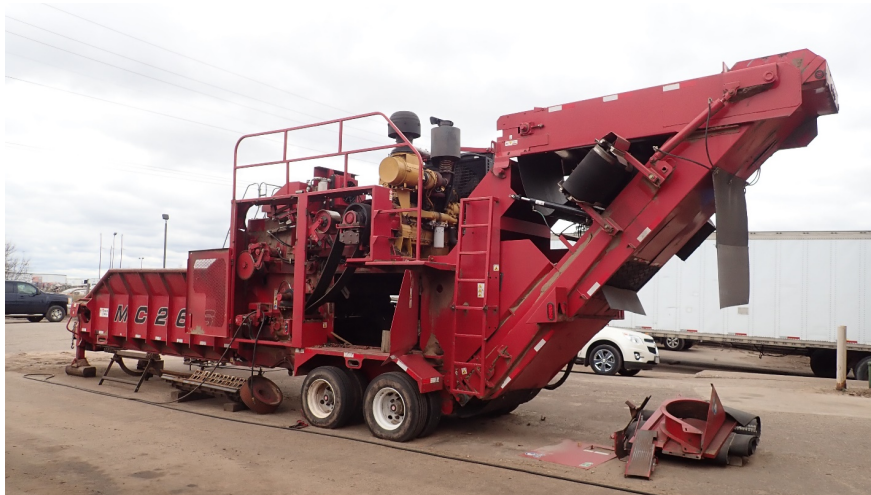
- Grinder was being utilized to pulverize wood.
- A few months after the grinder was purchased new, it suffered several mechanical failures and required substantial service part replacement.
- Since the part replacement, persistent breakdowns have occurred.
- Nearly \$100,000 has been spent for service parts and repairs to keep the grinder operating.
- Three years after the grinder was purchased new, the insured determined that the chopper had suffered nearly catastrophic failure and could no longer operate.

- The long list of failures to the grinder was attributed to continual operation with a severe vibration due to an improperly repaired main rotor, which was operating out of dynamic balance since the first rotor tooth mount failure.
- ILC concluded that the recent failure of the grinder was the result of improper repairs, a lack of proper and timely maintenance, and user misuse.
- ILC concluded replacement of the machine was not necessary to restore proper operation.
- The required repairs, totaling \$125,967, were the culmination of continued operation of a machine, repaired without adherence to industry accepted practices or original equipment manufacturer support.
