Vulcanizing Equipment Loss

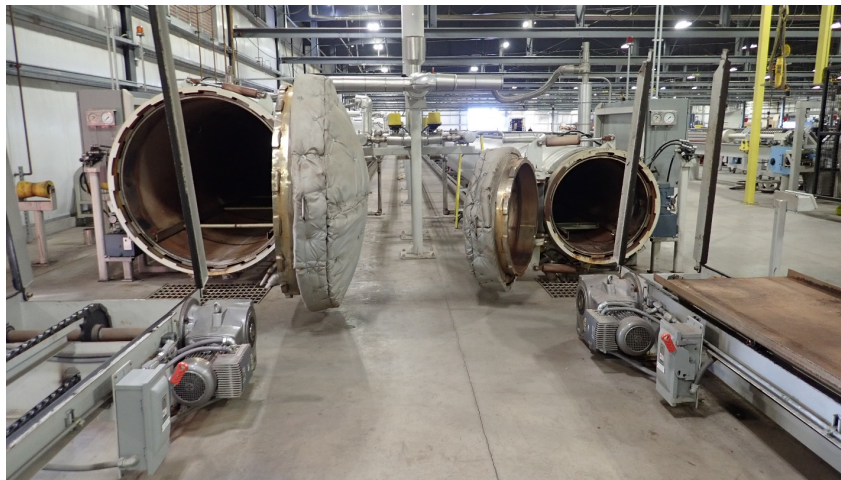
- Insured's personnel discovered that stainless steel steam injection/water cooling piping within one of the (2) vessels had broken due to corrosion.
- Upon closer inspection by the personnel, both vulcanizing pressure vessels were found to exhibit cracks in multiple locations.
- The insured was using water to cool the vessels/product in an effort to expedite production.
- Tests were performed on the cooling water, which showed the presence of chloride contamination.

- It is concluded that the stainless steel, which generally does not corrode to the observed magnitude, that composed the vulcanizing pressure vessels was adversely affected by the high concentrations of chloride in the cooling water.
- The corrosion and crack development within the vessels were consistent with the culmination of long-term conditions and inconsistent with a sudden and incidental event.
- ILC confirmed that continued use of the pressure vessels was a safety concern, repair of the pressure vessels was not prudent, and replacement of the pressure vessels was the only way to safely return the pressure vessels to production.
- ILC confirmed the costs of the Ø3' pressure vessel of \$468,797 and the Ø5' pressure vessel of \$681,950.
