Fire Damaged Mining Equipment

ILC Assignment:

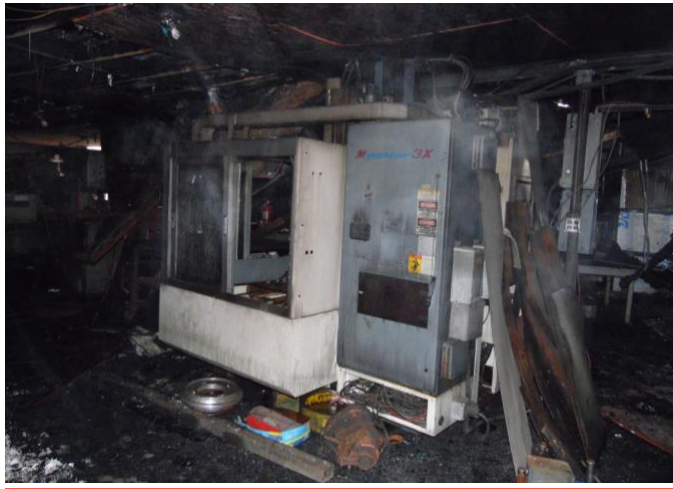
- Upon inspection, ILC discovered that most of the equipment was located in the portion of the building where the fire had originated.
- Inside the machine shop, ILC found various pieces of equipment, including manual lathes, mills, CNC machinery, and a forklift.
- The machinery inspected by ILC did not appear to be candidates for repair or restoration with a few exceptions. At the back of the facility, ILC documented an air compressor and air dryer that both were candidates for repair.

- ILC determined the full replacement value of the machinery and equipment in the facility to be \$1,573,000.
- Upon our final review of the damaged equipment, ILC validated a total of \$720,989 for the full replacement and repair value of the damaged equipment.
- ILC determined the ACV of the fire damage equipment to be a total of \$325,376.
