## Hydronic Heating Boiler Loss

### ILC Assignment:

- ILC performed an investigation into the cause of damage and reparability of Hydronic Heating Boiler Equipment.
- The insured had been operating a commercial greenhouse plant nursery and mentioned there being several boiler failures involving leaks since the unit was installed in 2017.

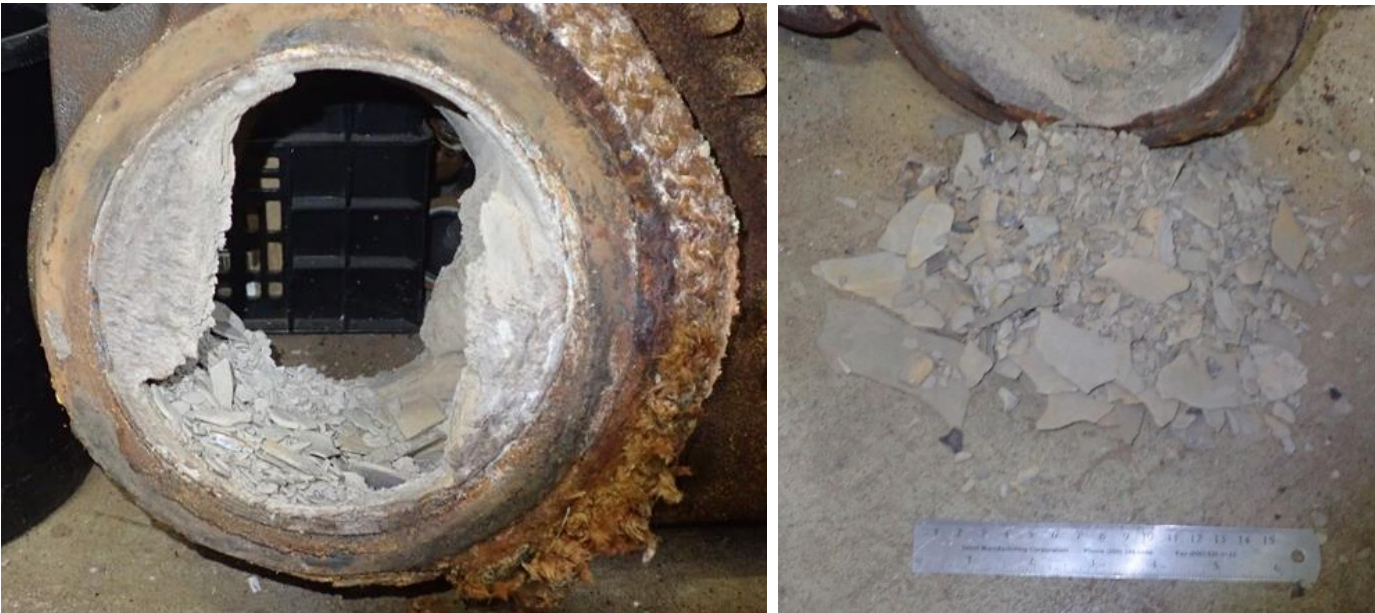
- ILC determined the cause of the water leaks to be a result of excessive mineral concentrations within the boiler water loop. The increased mineral concentration was due to the water chemistry.
- The cause of the increased concentration of minerals within the equipment was attributed to a lack of water chemistry monitoring, a lack of proper and timely maintenance, two of the system steam traps venting to the atmosphere, and a system blowdown occurring in an incorrect location where it does not adequately drain mineral contaminants.
